30-meter upgrade project

Upgrade of the IRAM 30-meter telescope

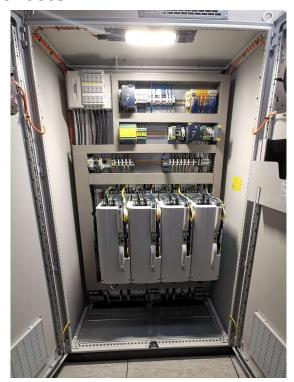
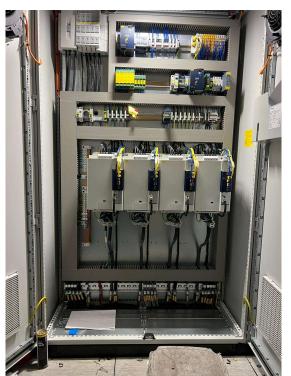
Since the initial tests, we have observed significant vibrations in the main axis. After ruling out gearbox-related issues, we identified that these vibrations resulted from abnormal velocity-torque control of the motors due to a wrong selection of motors and amplifiers.

The first strategy was implemented during the first week of September. The Lenze 9400 amplifiers in both azimuth and elevation were replaced with the Lenze i950 amplifiers, which are 90 times faster.

As a result, ripples in both torque and velocity have been reduced to amplitudes below 1%. However, it appears that these ripples are primarily absorbed by the high inertia of the structure and the gears but have not completely disappeared.

- Replace the amplifiers with others featuring a faster control loop while retaining the existing motors.
- Replace the amplifiers with others featuring a faster control loop and change the motors by synchronous ones.

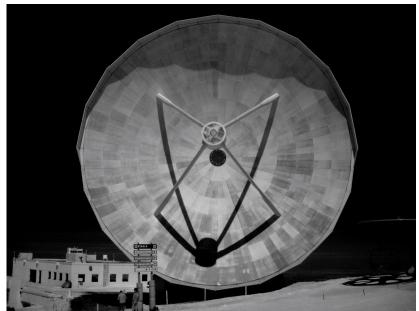
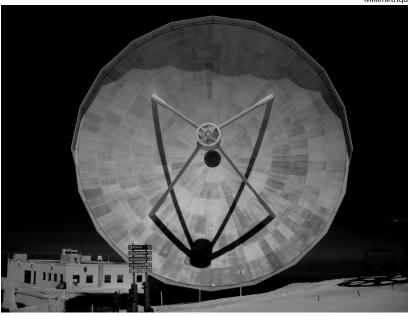
The surface TiO_2 paint has been slowly but steadily degrading over the past years, at a rate of ~1 μ m/year.

Some parts have degraded from $^{\sim}50\mu m$ to $10\mu m$ thickness. The dark primer starts to show-up. This can contribute with square-add $^{\sim}35\text{-}40\mu m$ to the surface r.m.s. budget.

Due to the observed aging/weathering of the paint the following effects are observed:

- Degraded thermal performance in day time (specially critical for NIKA).
- Degraded surface rms due to uneven paint layer (day and night) and panel buckling.

Renewing the paint is likely the most urgent thing to do in order to improve the 30-meter!

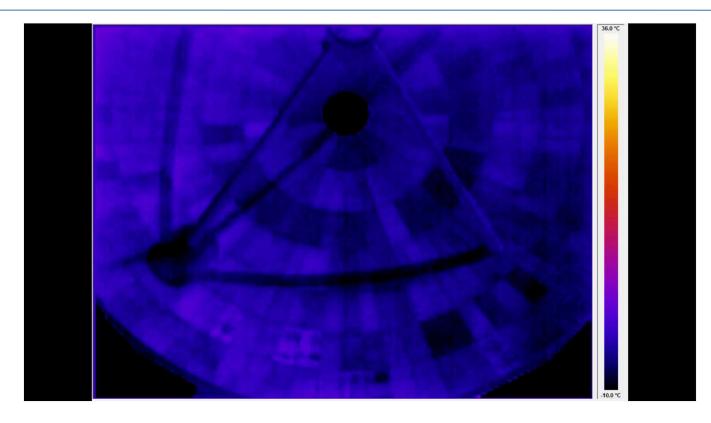
During the day adjacent pannels show temperature differences of 20 C degrees.

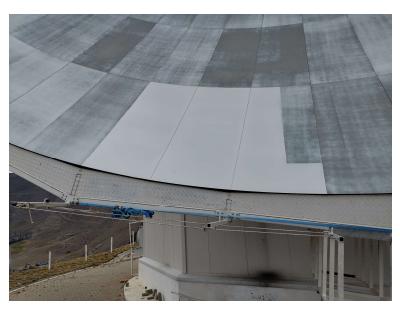
Painting Test 2022

- Average of 50 μ m mostly accomplished
- Margin of ±5μm peak-to-peak non achieved
- Paint application procedure to be redefined to avoid peak-to-peak margin breaking

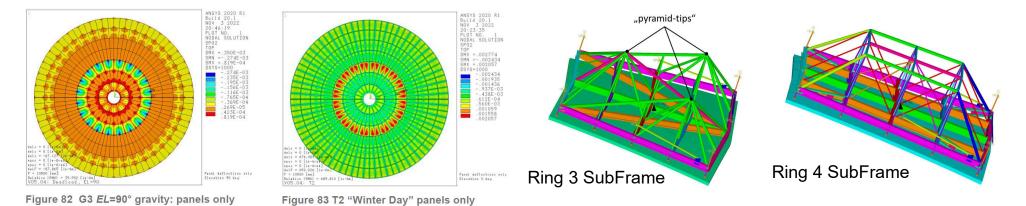
A **Finite Element (FE) study of the telescope structure** was conducted to provide an overview of the impacts of environmental factors such as gravity, wind, and temperature on the surface deformations of the main reflector at both low and high elevations. The study aimed to assess the most effective approaches to reduce these deformations. It found that panels of ring 3 of the antenna have a significant deformation due to gravity and thermal loads.

Sub-frames of ring 3 of the surface are different than the sub-frames of other rings. FE elements show that this effect can reduced after reinforcing the sub-frames connecting the free vertex.

690 µm RMS

40 µm RMS

- A conservative approach is proposed for the surface painting, involving in-situ cleaning using laser technology followed by repainting the telescope surface to meet stringent accuracy requirements. This process would be scheduled for the summer of 2024, pending the successful completion of ongoing laboratory tests. Subject to weather conditions, this process. It will require a downtime of the 30m telescope lasting between 2 to 3 month
- It is **discouraged to install actuators**. The effort for an integration of actuators in the BUS and to evolve the control system is extremely high compared to its expected benefits.
- To address gravitational deformation at low and high elevations, it is recommended to **reinforce the sub-frames of ring 3**. The design and composition of the reinforcement will need to be performed beforehand.
