30-meter upgrade project

Upgrade of the IRAM 30-meter telescope

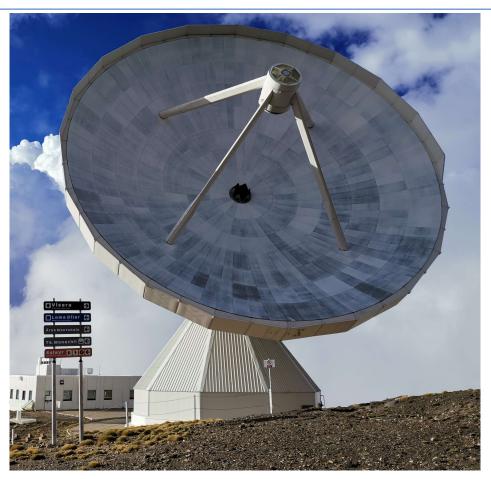
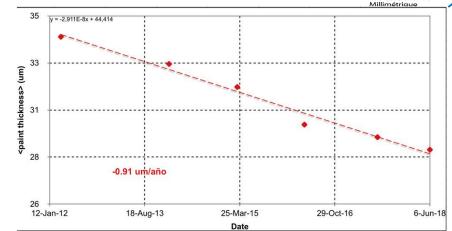
The surface TiO_2 paint has been slowly but steadily degrading over the past years, at a rate of ~1 μ m/year.

Some parts have degraded from $^{\sim}50\mu m$ to $10\mu m$ thickness. The dark primer starts to show-up. This can contribute with square-add $^{\sim}35\text{-}40\mu m$ to the surface r.m.s. budget.

Due to the observed aging/weathering of the paint the following effects are observed:

- Degraded thermal performance in day time (specially critical for NIKA).
- Degraded surface rms due to uneven paint layer (day and night) and panel buckling.

Renewing the paint is likely the most urgent thing to do in order to improve the 30-meter!

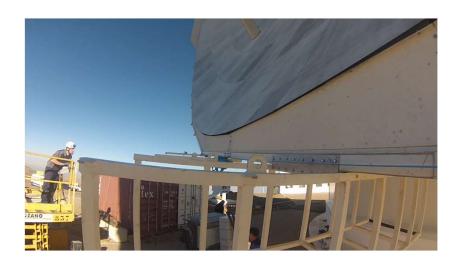
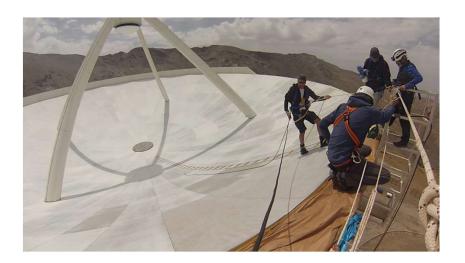
- On 2022, we carried out with our main contractor OHB a paint test campaign (laser cleaning + painting panels of the external telescope ring) and the evaluation of results is in progress.
- In order to define the thickness tolerances for the cleaning and primer and topcoat application. It has required to characterise radioelectric properties of new paint samples at IRAM: dielectric constant and attenuation/losses.
- Final thickness requirement: 50 μ m ±5 μ m peak-to-peak (cleaning: 10 μ m, primer: 20 μ m topcoat: 20 μ m)
